Ball Joint Failure

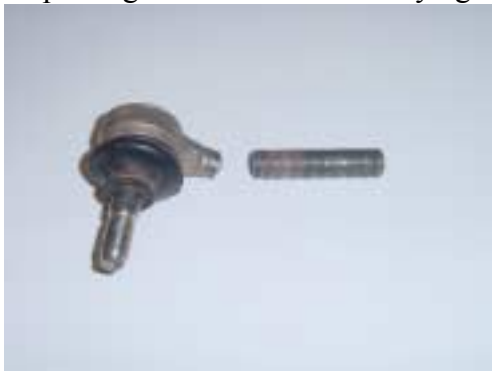
Illustration #1

The third design, and the primary focus of this article, uses automotive style ball joints. The use of ball joints is a fairly economical option for both the manufacturer and consumer alike. This design typically provides an adequate range of motion for standard travel a-arm geometry and stands up to dirty environments very well. The ball joint design also has its limitations. Because of its original design intent (automotive tie rod ends) the ball joints used do not have very good longevity when submitted to extreme load cases such as flat landing from a big jump. When a ball joint is used in an a-arm application, it is being subjected to bending stresses. In its automotive application, ball joints are primarily subjected to tensile and compressive loading. The following illustration depicts what can happen to a ball joint when subjected to bending forces surpassing its intended load carrying capacity.

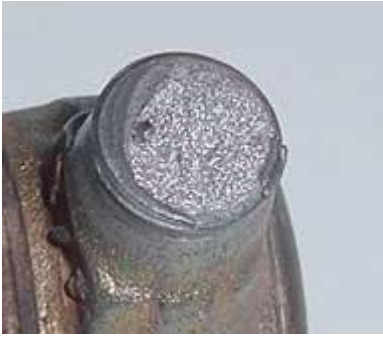
Illustration #3 helps us to determine the type of failure that has occurred. The half moon shaped marks around the left edge are commonly referred to as “beach marks” resembling the marks that waves leave in the sand on a beach. These marks are a tell tail sign that the fracture was initiated from a fatigue crack, in this case, forming at the root of the thread. Another bit of information that can be obtained from this sample is that even though the failure was initiated from a fatigue crack, the crack did not propagate very far before the brittle fracture occurred. The ultimate strength of a material is the stress level that a part can withstand before a catastrophic failure occurs. Because the stress in a part is equal to the applied force divided by the cross-sectional area of the specimen ($\sigma = F/A$), as the area decreases, the stress increases. In this case the reduction in cross-sectional area was very small when the part fractured. This tells us that the loads being applied to this sample were generating stresses that were approaching the ultimate strength limit of the material even before the reduction in area occurred. The only way to combat this failure mode is through a material composition change or an increase in shank size. This is the very reason why our MX Tech arms use heims with such a large diameter shank. This particular failure occurred while the rider was skying a 70 foot table top. The rider landed a little front heavy and upon impact, snapped the ball joint off. This resulted in some bumps and bruises and a moderate concussion.

Does this mean that all arms that are built with ball joint are bad? No, it just means that you need to purchase components that are designed for your intended use. Because of the low price point and their maintenance free design, arms constructed using ball joints are a great choice for the recreational trail or dune rider who wants to add stability and increase cornering performance. If your intended use is motocross type applications, we would strongly recommend going with the higher priced, more robust designs. Arms constructed using heim joints are a great alternative that won't break the bank.
